INSTALLATION RESTORATION PROGRAM

SITE INVESTIGATION REPORT

VOLUME I – REPORT

106TH RESCUE GROUP NEW YORK AIR NATIONAL GUARD WESTHAMPTON BEACH, NEW YORK FRANCIS S. GABRESKI AIRPORT

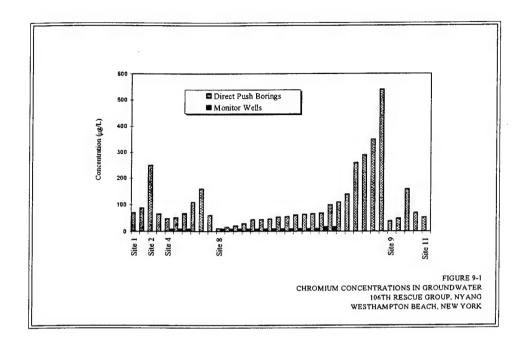
Chromium was the only analyte detected above reporting limits in groundwater samples collected from Site 1. The metal was detected above action levels in samples collected from two direct push borings. However, elevated concentrations of chromium in samples obtained from the direct push borings are not considered representative of groundwater quality at the facility.

Figure 9-1 shows chromium concentrations in groundwater samples collected from the direct push borings and wells. None of the samples collected from the wells contain chromium in excess of action levels. In contrast, many samples obtained from the borings exhibit concentrations greater than action levels and nearly all concentrations are significantly higher than those detected in the well samples. Groundwater from the direct push borings was collected by driving or pushing rods to the desired depth and retrieving a sample through a screen attached to the end of the leading rod. The samples were typically more turbid than those collected from the wells and it appears that chromium leached into solution upon preservation with nitric acid, thereby artificially increasing the dissolved phase material. The metal is naturally present in soils at this site (see Section 8.2.1 for background soil concentrations) and would be expected to dissolve during preservation when the pH of the sample is reduced to 2 (it is unlikely that chromium is mobilizing naturally because the pH of groundwater at the facility is approximately neutral). Conversely, the well samples did not contain visible particulate matter because the wells had been developed and purged prior to sample collection. Based on this, and lack of a known source of chromium at this site, the elevated concentrations detected in groundwater collected from the direct push borings are attributed to dissolution of naturally-occurring chromium from suspended solids during sample preservation and are not considered representative of actual groundwater quality.
